## Preliminary Roost Assessment

Riverside Farm JK, Fairham Brook Lane, Bunny, Nottingham, Nottinghamshire NG11 6SQ

This report is prepared to inform the removal of welfare unit following a planning appeal with Rushcliffe Borough Council.

This proposal can be described as: Demolition of building

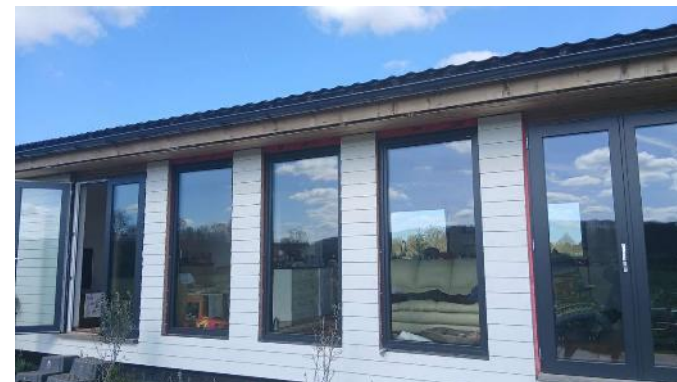
B1 is a single-storey, detached, timber-framed welfare unit. No internal voids were recorded.

In line with Good Practice Guidelines (Collins, J (Ed) 2023), B1 is assessed to have **moderate habitat value** for roosting bats due to the presence of external roosting features suitable for crevice dwelling bats and the surrounding habitat of value.

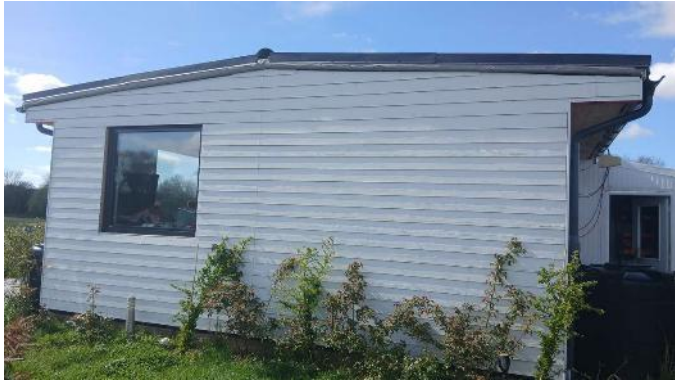
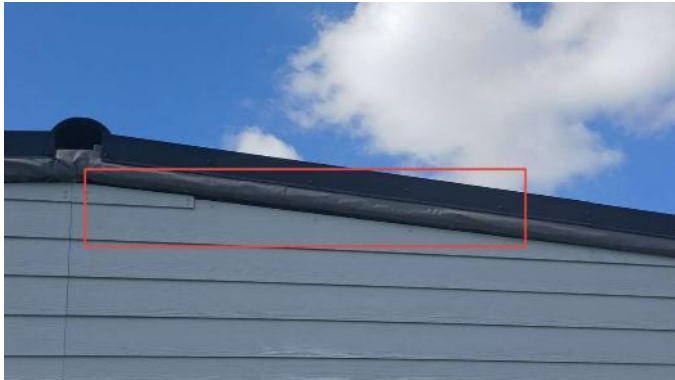
| | Roof | Corrugated metal sheeting | <p>The corrugated metal sheeting roof has a gabled structure. There are gaps on the gable ends on both the eastern and western elevations where the roof meet the walls, which could allow access into the cavity between the roof and internal ceiling, as well as into the wall cavities, presenting a high-suitability crevice feature for roosting bats. The ridgeline of B1 is comprised of curved metal and is uncapped on both ends, which could be accessed by roosting bats. However, the gap is large; running from the eastern elevation to the west, which would allow drafts to pass through, with addition to the metal material, the gap is likely to offer poor thermal stability and therefore does not offer suitable conditions for bat roosting. There is another gap that runs below this, separated by breathable roof membrane which would reduce the drafts and may offer more stable temperatures, and could be used by crevice-dwelling bats.</p> | <p><i>Eastern elevation of B1</i></p> <p><i>Gap at gable end on the eastern elevation</i></p> | |

- Two bat emergence/re-entry survey will be required on B1 (including checks of the bat box), requiring four surveyor positions with night vision aids (NVA) to provide full coverage of the building's elevations. If bat roosts are confirmed in the building, one additional survey may be required to characterise the roost and to inform an EPSL application to Natural England.

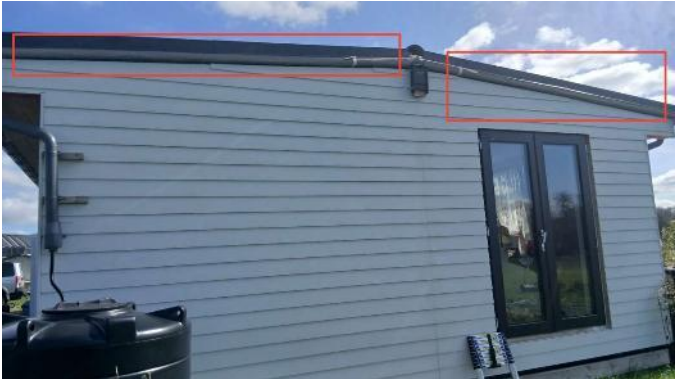
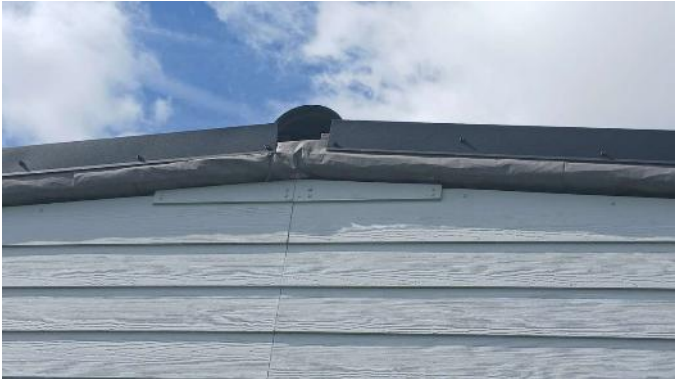
| | | | | <div><p><i>Gaps at gable end on the western elevation</i></p><p><i>Uncapped roof ridge</i></p></div> | |

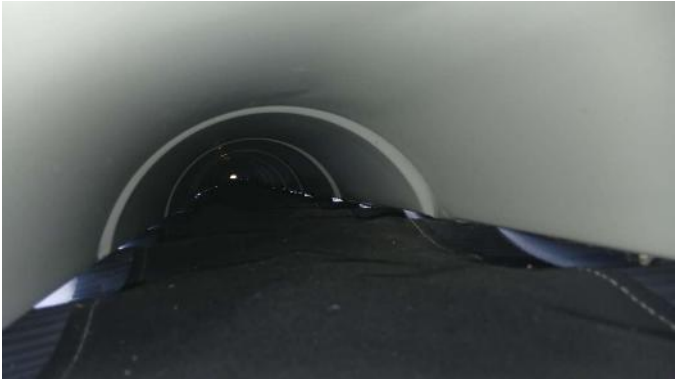
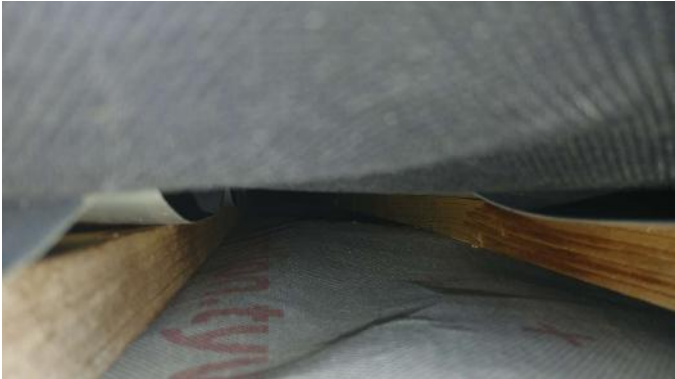
| | | | | <div><p><i>Inside the roof ridge</i></p><p><i>Gap beneath the roof membrane along roof ridge</i></p></div> | |

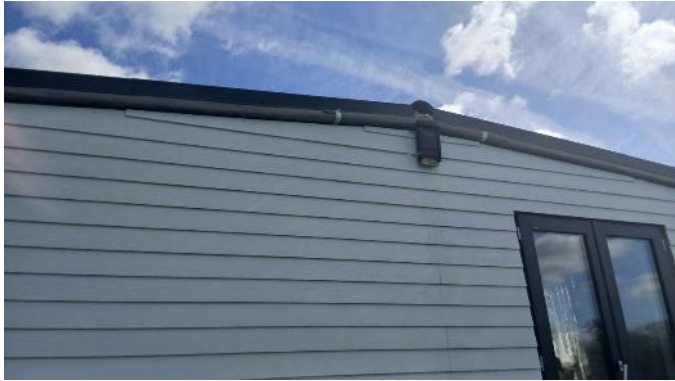
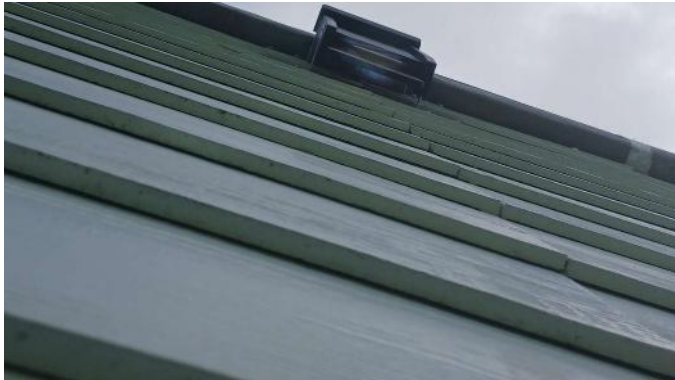
| | Walls | Timber-framed | <p>The walls appear to be in good condition. A bat box is present on the western elevation, providing suitable roosting habitat for crevice-dwelling bats; however, no direct or indirect signs of bat presence were observed. There is a section of unfinished wall on the northern elevation that is missing a timber board, which would allow access into the wall cavity, presenting a high-suitability crevice feature for roosting bats.</p> | <p><i>Bat box on western elevation</i></p> <p><i>Inside the bat box</i></p> | |

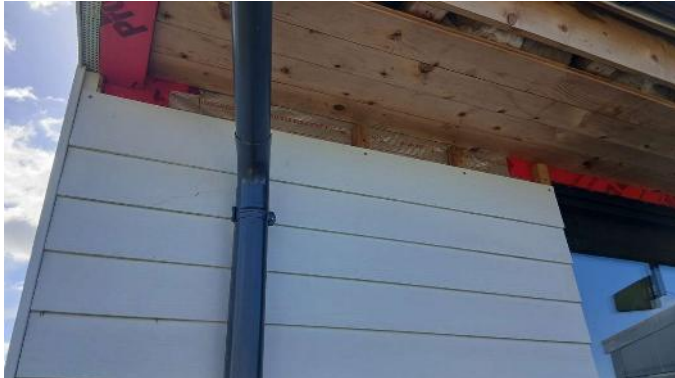
| | | | | <p><i>Section of unfinished wall on the northern elevation</i></p> | |

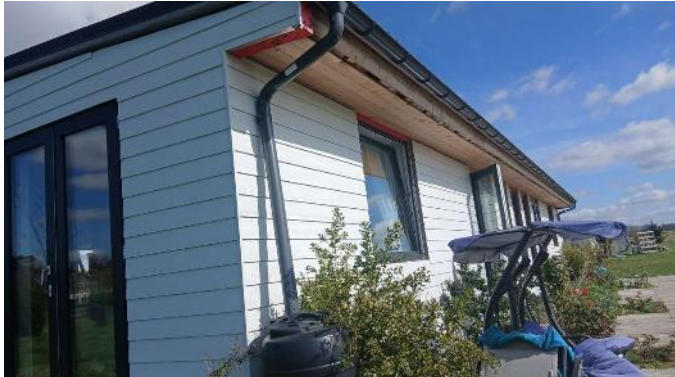
| | Eaves | Timber | The timber soffits have gaps present along the entire length of the northern and southern elevations, which would allow access into the soffit boxes for roosting bat species. | <p><i>Soffit gaps along the northern elevation</i></p> | |

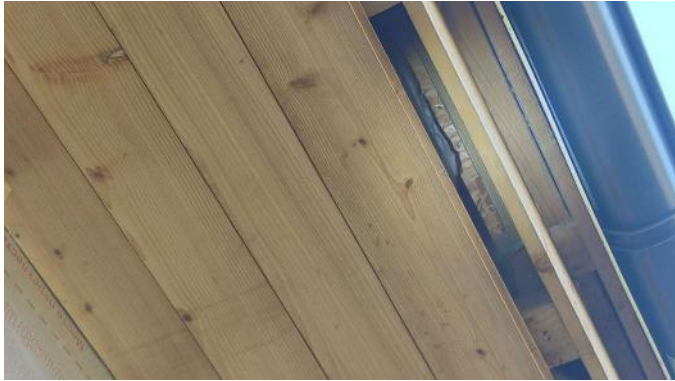
| | | | | <p><i>Soffit gaps on the southern elevation.</i></p> | |

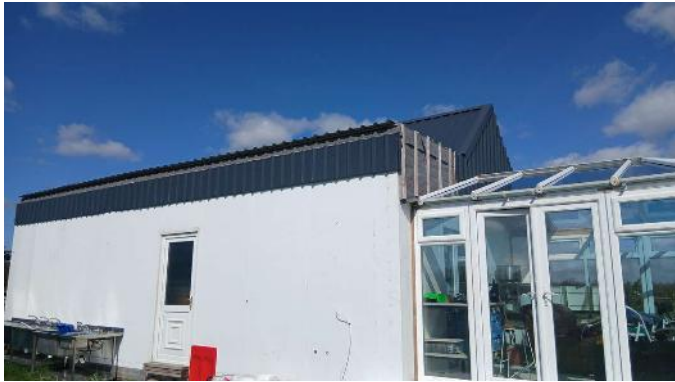
| <div> <div>Building B2 Description</div> <div> <p>B2 is an agricultural storage building with an adjoining conservatory. The main roof is gabled and clad in corrugated metal sheeting, the walls are comprised of metal sheeting, and the conservatory is comprised of uPVC and glass.</p> <p>Although B2 will not be impacted, the building was assessed due to its proximity to B1. There are some metal sheets that overhang the eaves of the northern elevation that create a gap that could be accessed by roosting bats; however, the metal surface provides little grip, is non-porous and impermeable, and has poor thermal stability, and therefore does not offer suitable conditions for bat roosting. The building is well-sealed with no areas of roosting habitat available for crevice dwellers, and no external access into the building, therefore no habitat value for void dwelling bats. No bat evidence was recorded during the survey of this building.</p> <p>In line with Good Practice Guidelines (Collins, J (Ed) 2023), B2 is assessed to have <b>negligible</b> habitat value for roosting bats.</p> </div> </div> | | | | | |
| | | | | <p><i>B2- southern elevation</i></p> | |

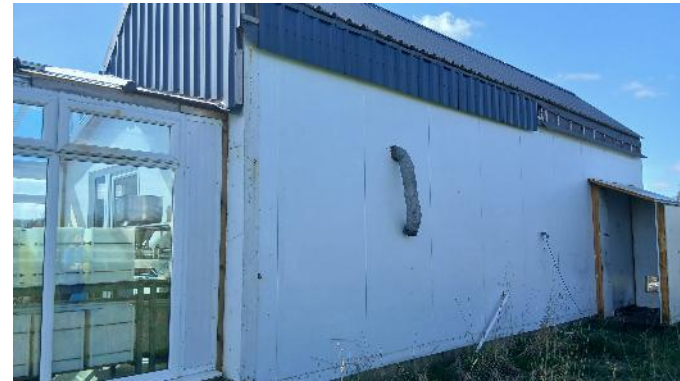
*B2 – northern elevation*
