# **Investigation into the Incidence of Acute Myeloid Leukaemia at Tollerton Mobile Home Park**

**September 2008**

## **Rushcliffe Borough Council**

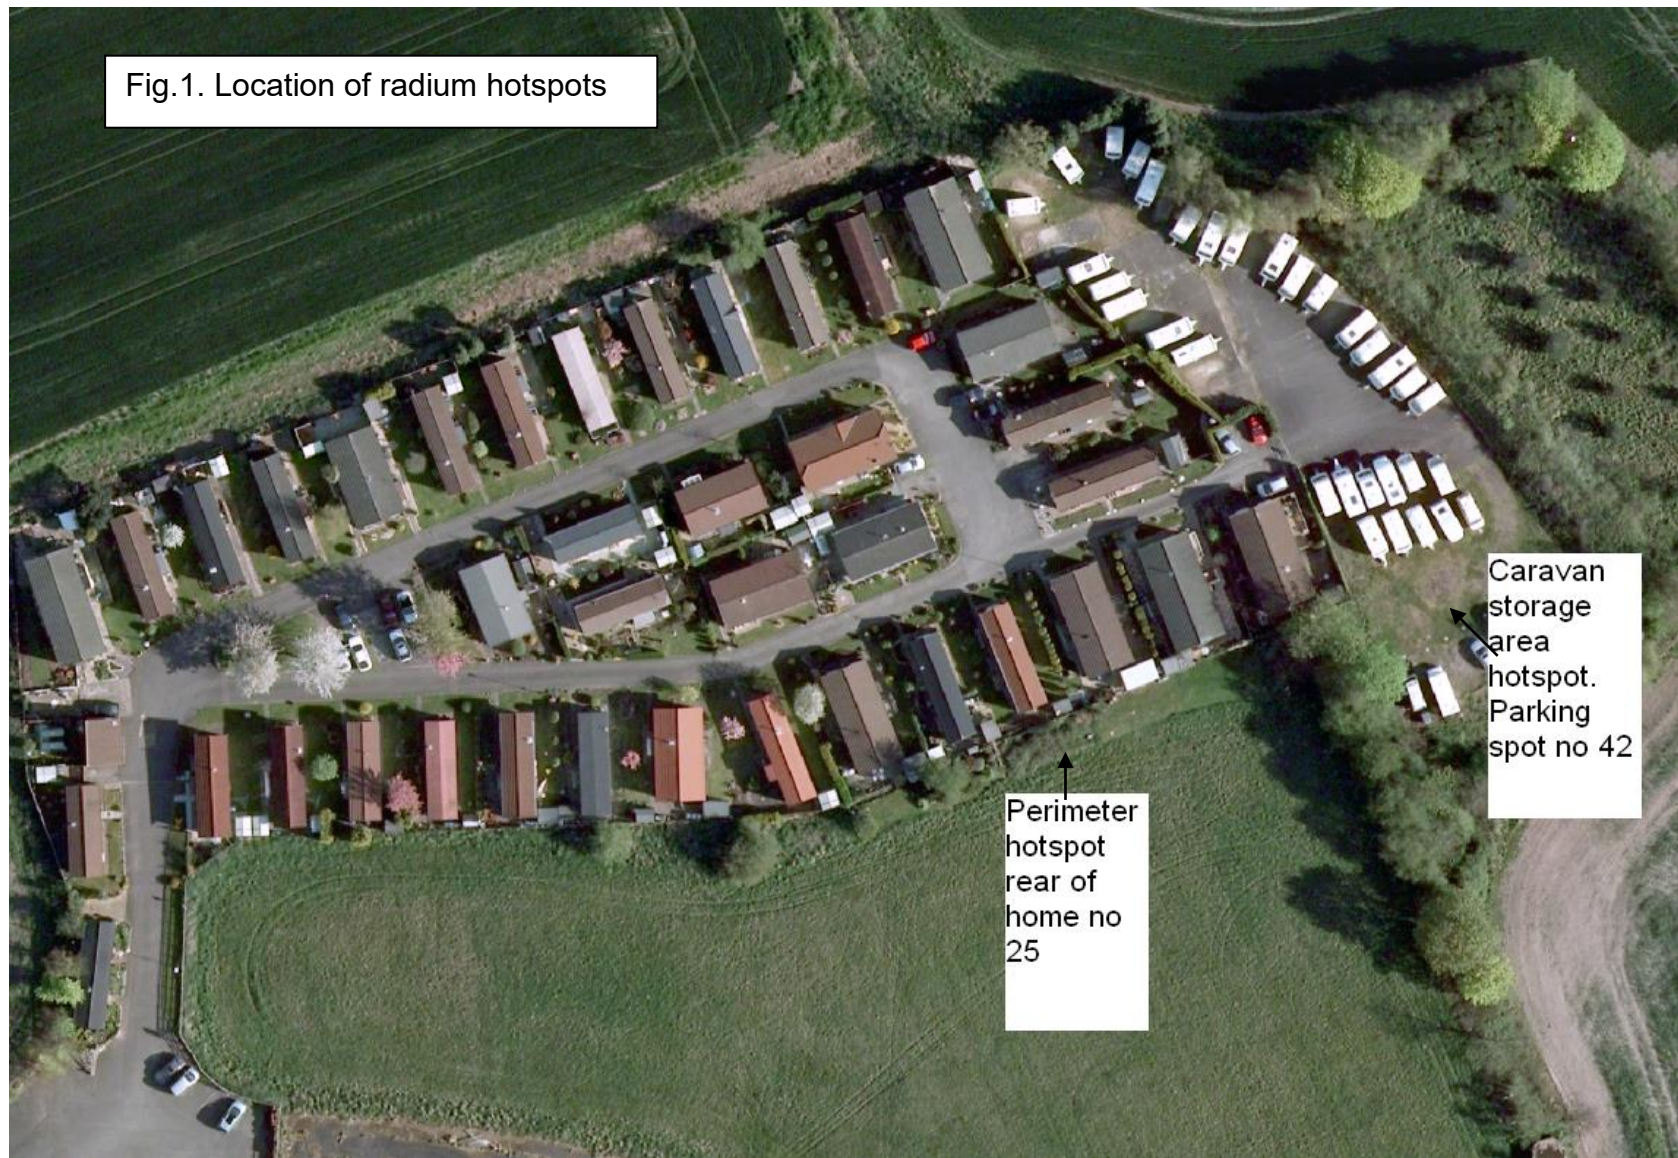
Fig.1. Location of radium hotspots

In terms of above-background readings, two locations were identified (fig.1), as follows:

### **1. Outside of the site perimeter (Home no. 25) on the adjacent airfield**

This consists of a small rectangle (approx 2 metres by 4 metres) of bare ground immediately beyond the site boundary. The gamma spectrometry results indicate the presence of shielded radium-226, i.e. the activity is likely to be buried beneath the surface layer of soil. Elevated levels of gamma radiation are detectable over the entire patch of ground, with a maximum gamma dose rate of 1  $\mu\text{Sv/h}$  at the ground surface. The radiation levels reduce rapidly with distance; at the nearest occupied position on the site (the garden decking to the rear of home no. 25) the dose rate is within the normal background range.

## **2. Caravan parking area at the far end of the site (parking plot 42)**

This consists of a small patch (approx 30 cm in diameter) of ground. The gamma spectrometry results indicate the presence of radium-226, and the overall pattern of measurement results suggest that the activity is in the upper few centimetres of the ground. There was nothing obviously visible to the naked eye in the soil and would possibly be a flake of paint.

The maximum dose rate at the surface of the affected patch is 0.7 $\mu$ Sv/h, but reduces rapidly with distance, such that radiation levels are close to background at 1 metre away.

However, two areas of radium-226 contamination were detected outside this area: one in the airfield just outside the perimeter of the site, and one in the caravan parking area. It is stressed that the levels of contamination detected in these locations are not considered sufficient to pose a significant radiation hazard to mobile home residents and the levels detected are well below the 3mSv set out in the statutory guidance.

However, should the use of the land change (in particular should excavations be undertaken) then further investigation works would be warranted.
