DRAFT East Leake Conservation Area Appraisal and Management Plan March 2023

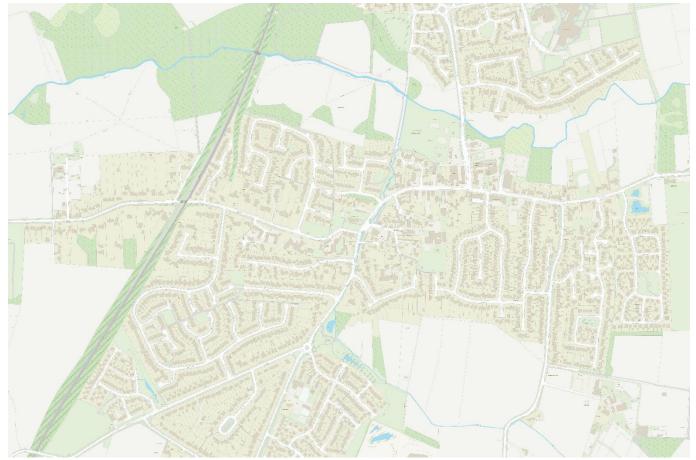
Figure 6 - OS Map of East Leake - Published 2023

Below is a map that describes the current plan, form and layout of the village/town.

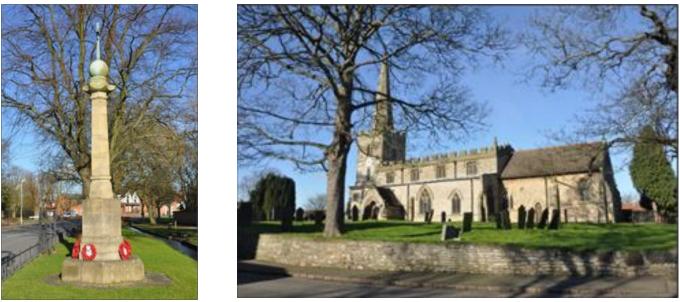
Figure 7 - 1914-18 War Memorial (Zone 1) Figure 8 - Church of St Mary and Church Yard (Zone 1)

There is also a War Memorial (see Figure 7), erected around 1919, composed of ashlar and incorporates copper elements. It stands on a hexagonal platform, with a chamfered octagonal base and a stepped hexagonal plinth. The central hexagonal column features a moulded base and scalloped capital, topped by a single copper cross.

The Parish Church, Church of St Mary's (see Figure 8), retains possible elements of Saxon brick work but is essentially Norman in design, being restyled in the first half of the 13th century in the Early English style. The south aisle arcade is from the 14th century and the clerestory, tower and battlements added in the 15th century. The chancel was largely rebuilt in 1886 and a reordering to remove the pews done in the early part of the 21st century has resulted in the church we see today.

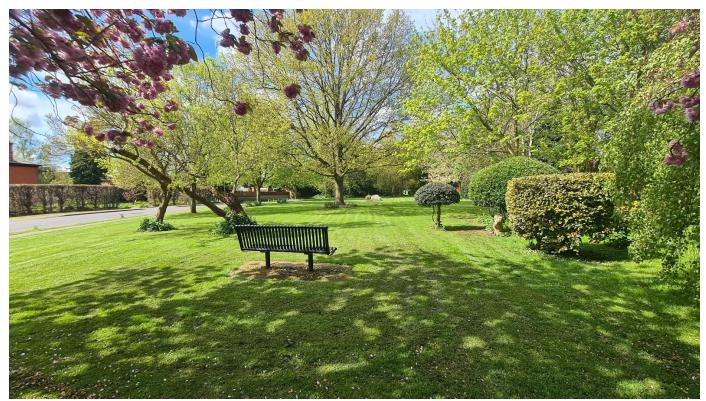
Figure 11 – The Glebe (Zone 2)

Main Street follows the line of the brook, with the Glebe (see Figure 11), pinfold (see Figure 10) and war memorial alongside the brook (see Figure 12), providing a peaceful green setting for the Church. Within The Glebe, there is a Millennium Stone, a large piece of gypsum, donated by British Gypsum, marking the spot of the buried village time capsule, buried in 2000 and due to be opened in 2045.

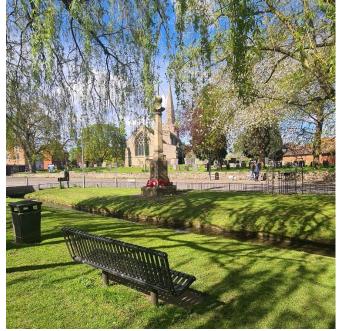
Figure 13 – Alternative View along Brook (Zone 1)

Willow trees line the Brook and serve as a reminder of the 19th century/early 20th century basketworks industry in the village (see Figure 13).

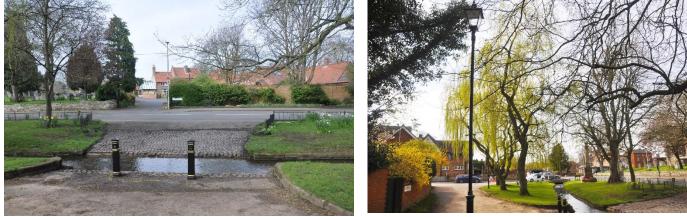
Figure 14 - The Ford (Zone 1)

The Victorian lantern lights along the pathway by the Brook (see Figure 15) and the recently renovated ford showing the old cobbles (see Figure 14) highlights the historic old centre of the village and the ambience it holds.

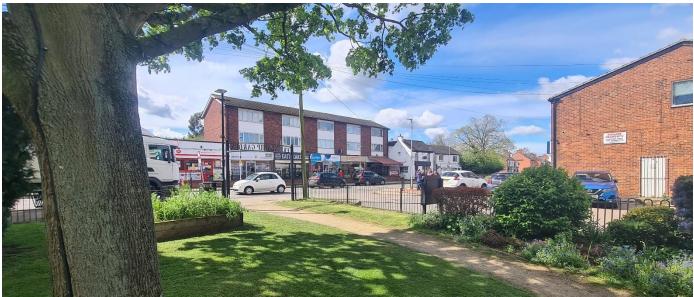
Figure 16 – Row of buildings which do not contribute to the character of the area and have the potential for enhancement Photo taken from the Friendship Garden (Zone 3)

The heart of East Leake, features a mix of shops, cafes, and services. The village centre often serves as a focal point for community activities and events. So, while the architectural interest of this area could be improved, there is social value to this area, being the central point for many of the amenities within the area.

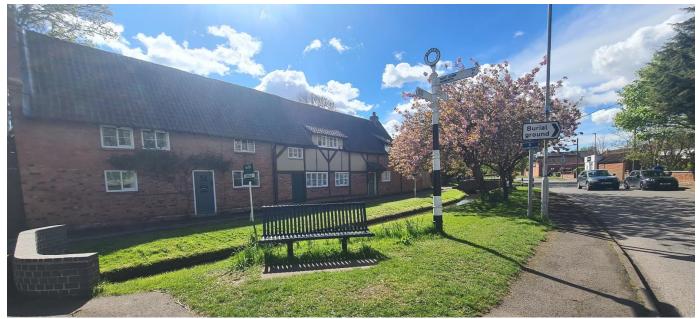
Figure 17 – Street furniture along the Brook and adjacent to timber framed cottages (1 and 3 Brookside) (Zone 1)

Black and white finger posts topped with a country roundel can be found along the brook, along with some other metal street furniture (see Figure 17).

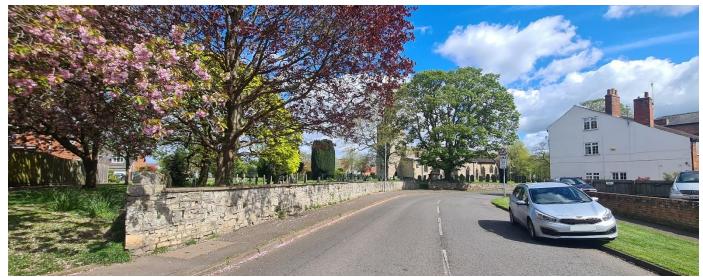
Figure 18 - Stone Wall at the Church and Brick Wall Opposite (Zone 1)

Boundary treatments include brick walls and metal railings (see Figure 20), with stone walls around the Church.

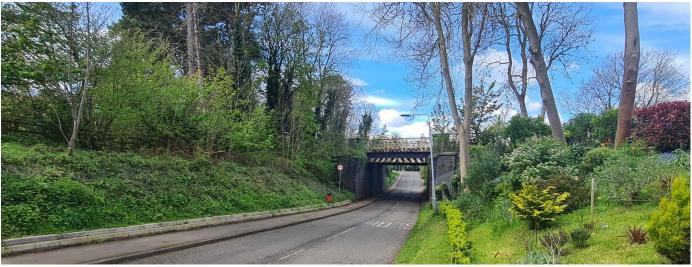
Figure 19 – East Leake bridge and former platform station (zone 2)

In this review of 2023, the boundary was extended to include the railway bridge and part of the platform that forms the entrance to the village from West Leake Road. The line is built along a very attractive, large, wooded cutting and had the Great Central style island platform. The platform was built on top of a road bridge (rather than a bridge with a road going over) which was a rare type with only a few of these on the Great Central Railway Line (other examples being Lutterworth and Finmere stations).

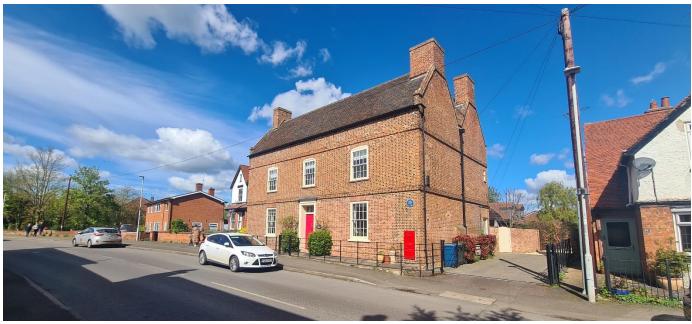
Figure 20 – Showing boundary treatments Walls and two types of metal railing (Zone 1 / Zone 3) Building in focus - 25 Main Street – John Bley's House / Former Post Office with blue plaque

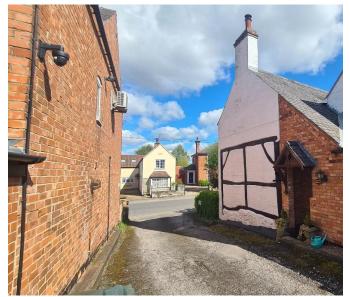
Figure 25 - Timber frame revealed on the side of a whitewashed house fronting Main Street (Zone 3)

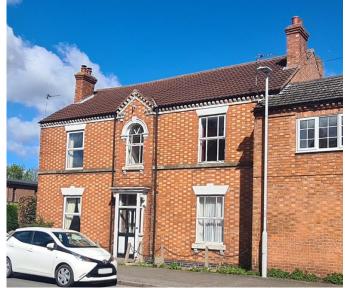
Figure 26 - Victorian house with vertically sliding sash windows, dentilated eaves, pantile roof and Flemish bond brickwork (Zone 3)

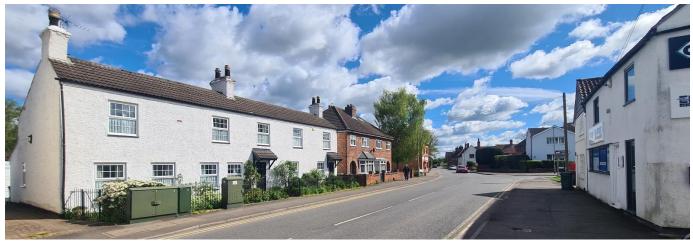
Figure 27 – Rendered and painted properties along main street (Zone 3).
